## **2003 AHERA** ASBESTOS MANAGEMENT REPORT

## **Heidelberg District Mannheim American Elementary School** Mannheim-Kaefertal, Germany

### Mannheim American Elementary School Mannheim-Kaefertal, Germany HE 3469

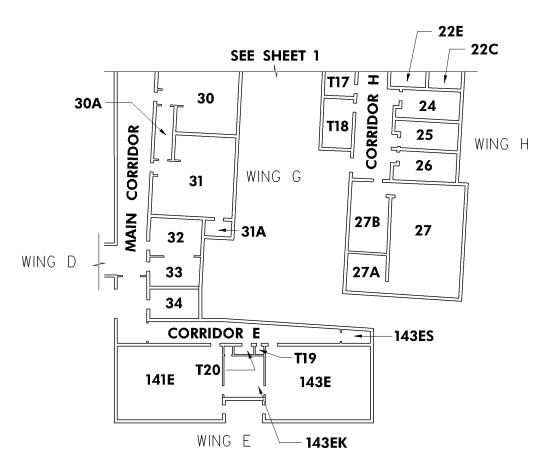
## BUILDING 0697 - WING B - PARTIAL FIRST FLOOR PLAN

BUILDING 0697 PARTIAL FIRST FLOOR PLAN

NOTE:
ONLY SAMPLES TAKEN
DURING THE AHERA
INSPECTION ARE SHOWN.
